Northern Periphery and Arctic Programme  
Northern Cereals – New Markets for a Changing Environment

## Drying and Storage of Harvested Grain

### Case Studies

Deliverables T2.2.1 and T2.2.2

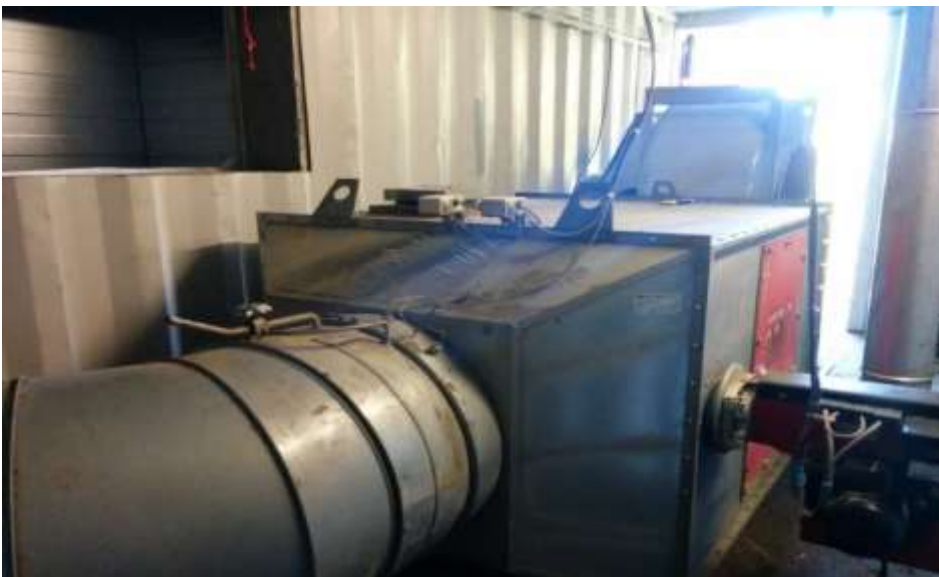
**Figure 3.** Blower and burner for the dryer. The opening in the upper left corner is for air intake where the residual heat from the dryer is used to preheat the air before drying.

The logger in the exhaust pipe was damaged so no data was obtained from this logger. This logger was also the only logger that was supposed to measure relative humidity as well as temperature. Figure 4 shows a graph of the measurements. It can be seen on the graph that at 2:30 am on the 26<sup>th</sup> the doors on the heating room were opened and the temperature in front of the blower falls instantly and the ambient temperature in the room falls below the temperature of the preheated air, until then it had been higher due to residual heat from the heater and the blower. This however had little or no impact on the temperature of the air in the inlet pipe and the change in oil consumption was not measured so it is hard to conclude if the preheated air has an impact on the energy consumption. The current setup for using residual heat might also cause extra load on the blower as there is more resistance in the airway.

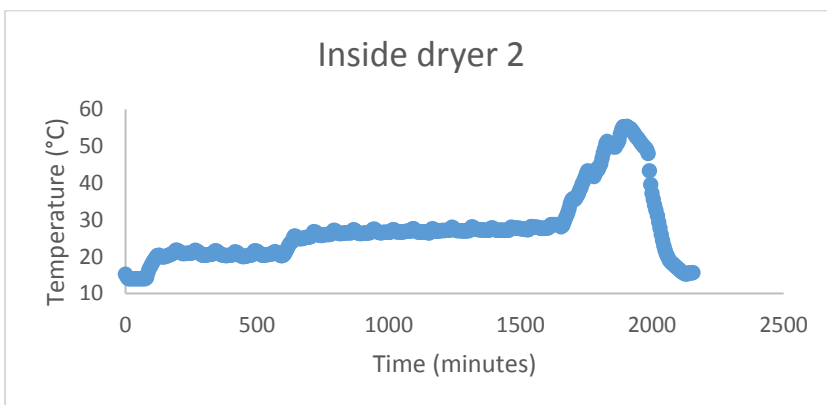
**Figure 7.** Air temperature inside dryer 2 during drying.

Graphs from temperature loggers are shown in Figures 5 to 11. Air temperature inside the dryers reached about 60-70 °C during a limited period. It can be seen that the air temperature differs within the dryers. Also the two dryers differed regarding temperature. It can be seen that the temperature of the air in the dryers and the exhaust air increased after about 2000 minutes. This indicates that grain drying should be complete.

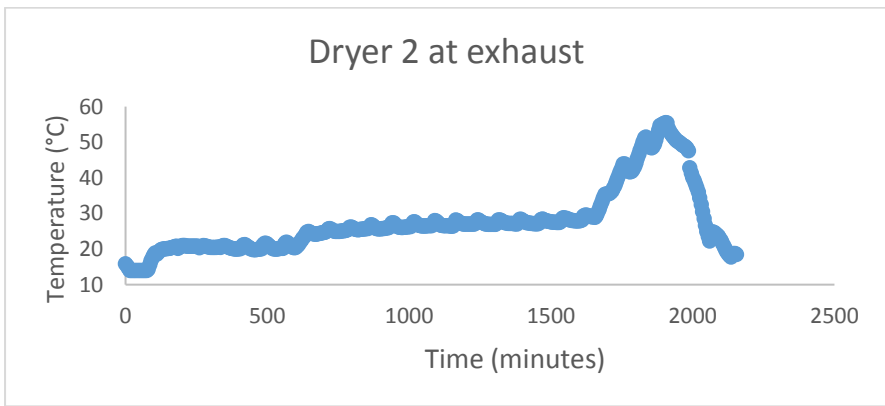
Figure 9. Temperature of exhaust air from dryer 2.

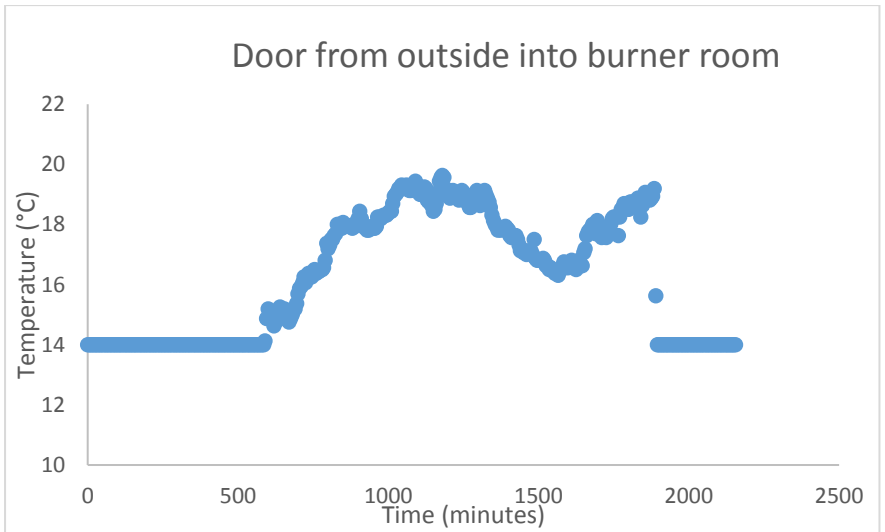
Figure 10. Outdoor air temperature.

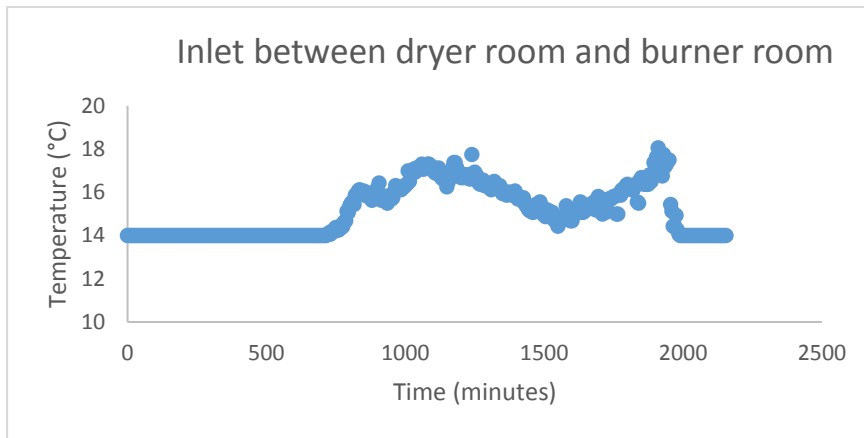
**Figure 11.** Air temperature at the inlet between the burner room and dryer room.

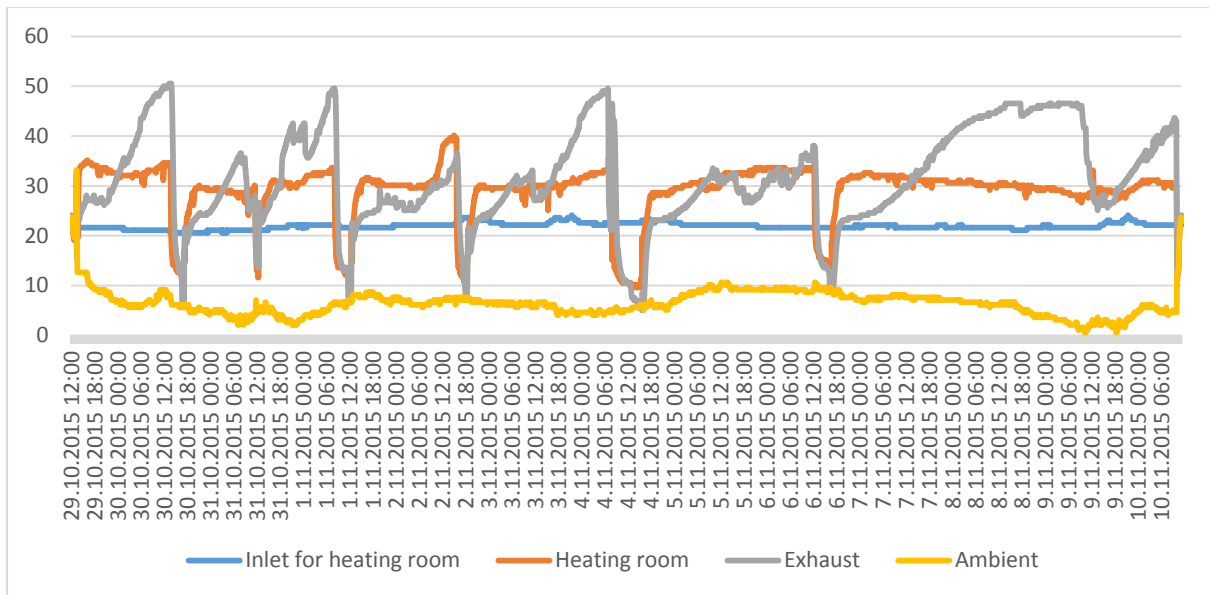
**Figure 13.** Results from temperature (°C) measurements at Belgsholt 2015.

Figure 13 shows the results from the first measurements at Belgsholt. The logger for the temperature on the air inlet for the dryer was broken when collected and its data were lost. The graph shows cycles in the process when the dryer was unloaded and loaded again. It is interesting to see the grey line rise through each cycle as expected as air cools down while picking up moisture and throughout the process the amount absorbed is reduced. Since there are no results for temperature of warm air entering the dryer it is hard to estimate if the drying went on for too long but it seems likely that this happened in the cycle starting 6<sup>th</sup> of November as the temperature of the exhaust air is constant for a long time.

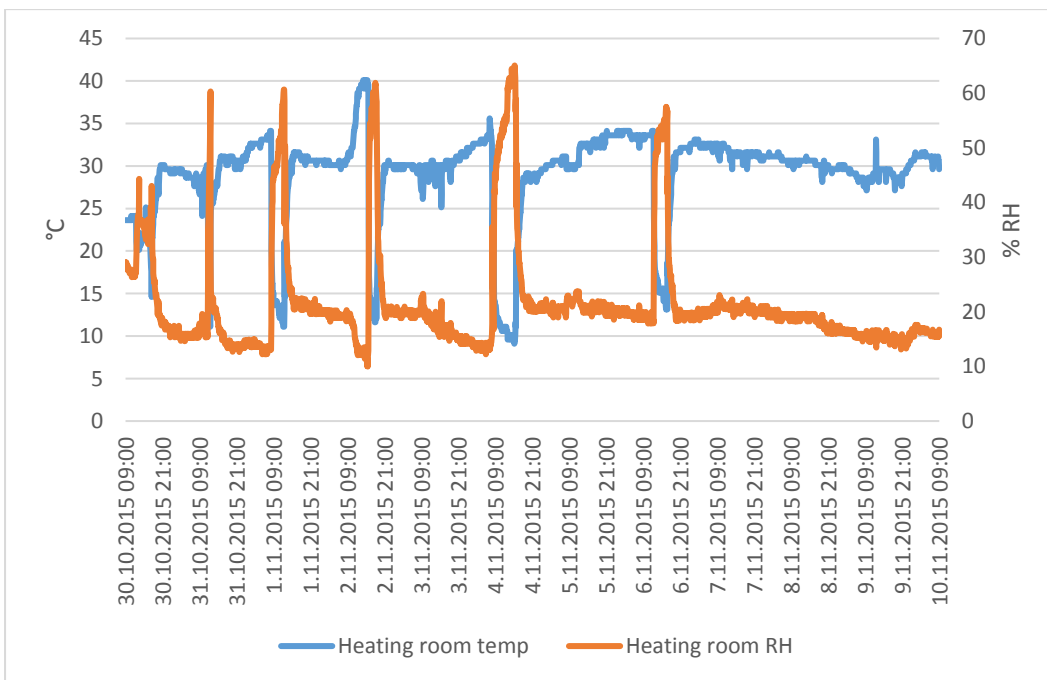
**Figure 15.** Temperature and relative humidity of the air in the heating room after going through the first heat exchanger.

Figure 14 shows that air during the drying was cold and the relative humidity was high, above 80 % for most of the time. Then after being preheated the air is much hotter and the humidity is lower as shown in Figure 15. As before, the cycles in the graph can be explained by loading and unloading of the dryer. Then the heating is turned off and the heating room shows temperature and humidity values that are closer to the ambient air than before. Figure 16 shows well what is going on in the drying cycle: at the start of each cycle, the exhaust air is relatively cold and the humidity high as the air absorbs moisture from the cereals, then, as the drying proceeds, the air becomes warmer and dryer.

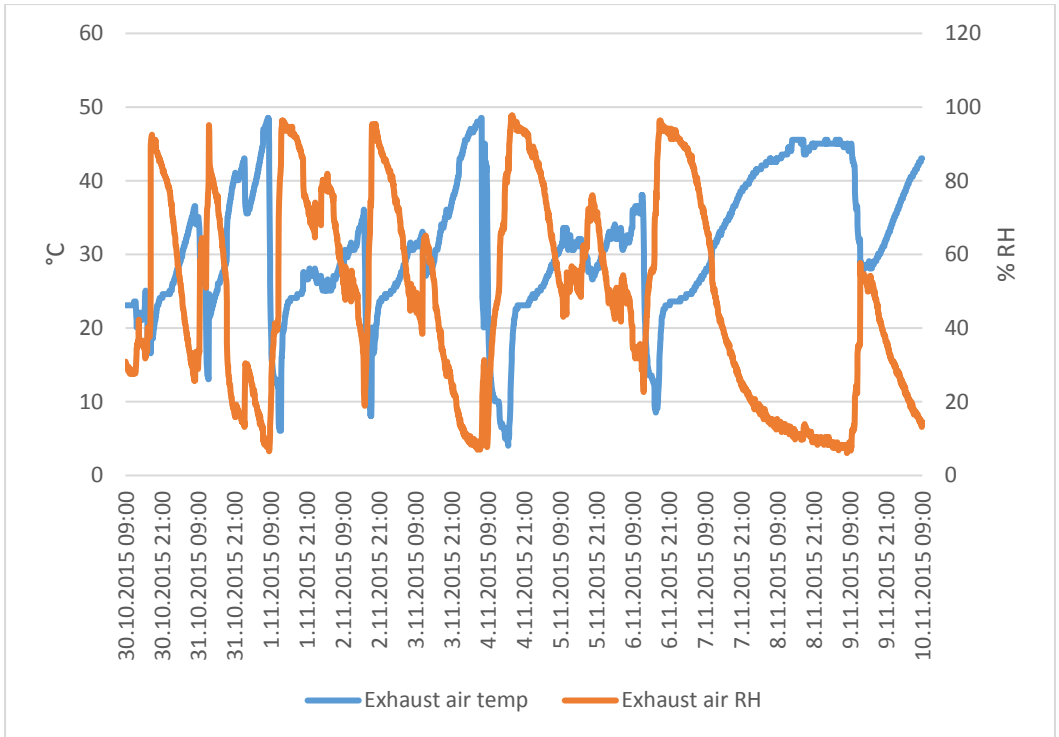
**Figure 16.** Temperature and relative humidity of the exhaust air after drying.

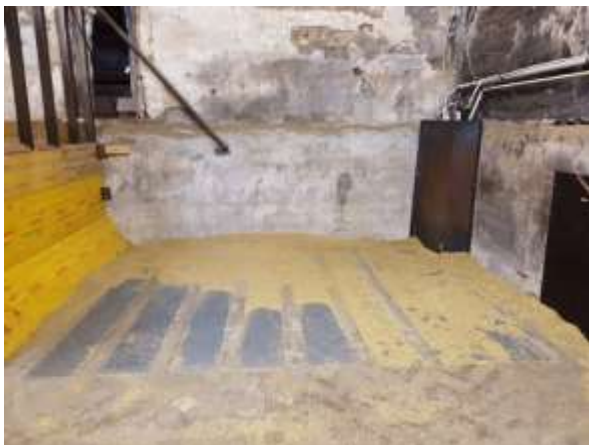
**Figure 17.** Facilities for incoming wet grain.

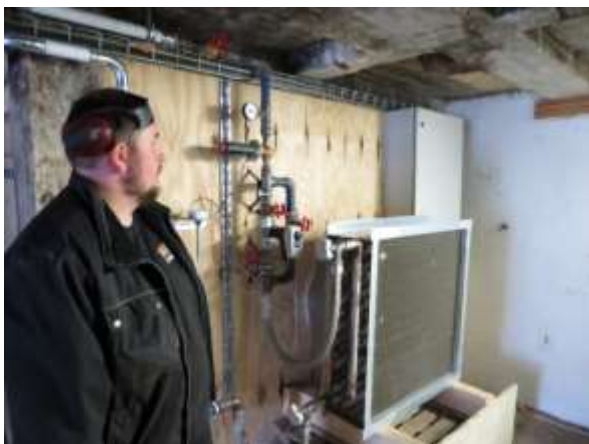
**Figure 18.** A heat exchanger for the incoming geothermal water.

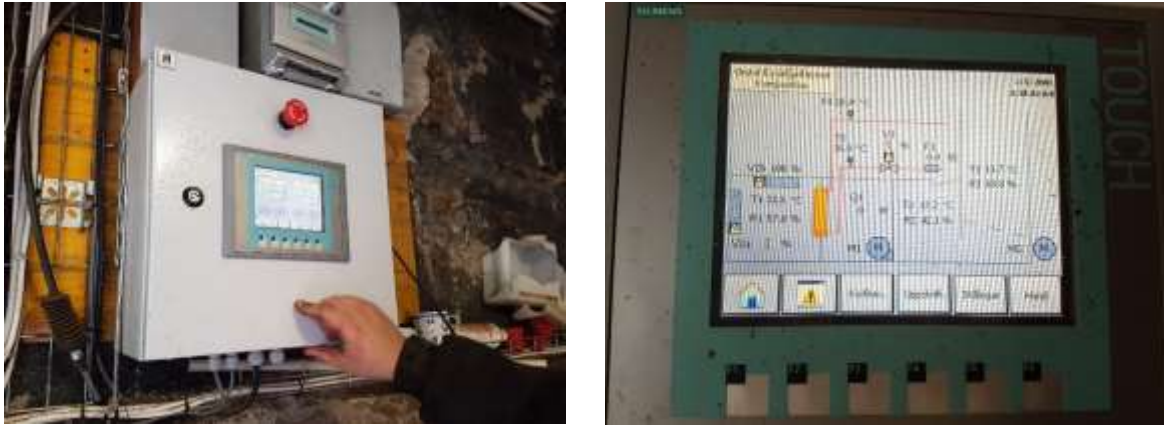
**Figure 19.** Monitoring unit for grain drying.

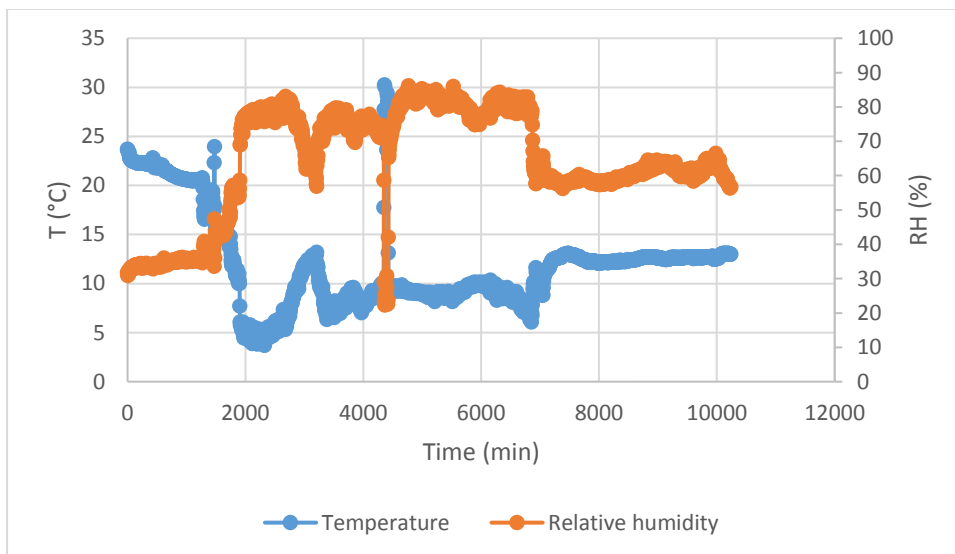
**Figure 20.** Temperature and relative humidity of intake air to the drying facilities.

The drying process at Grund farm was studied in 2015 and measurements carried out during the 2016 harvesting season. The temperature of the air for drying did not rise above 30 °C. This drying of grain has been sufficient. The low temperature should support maximum quality of grain.

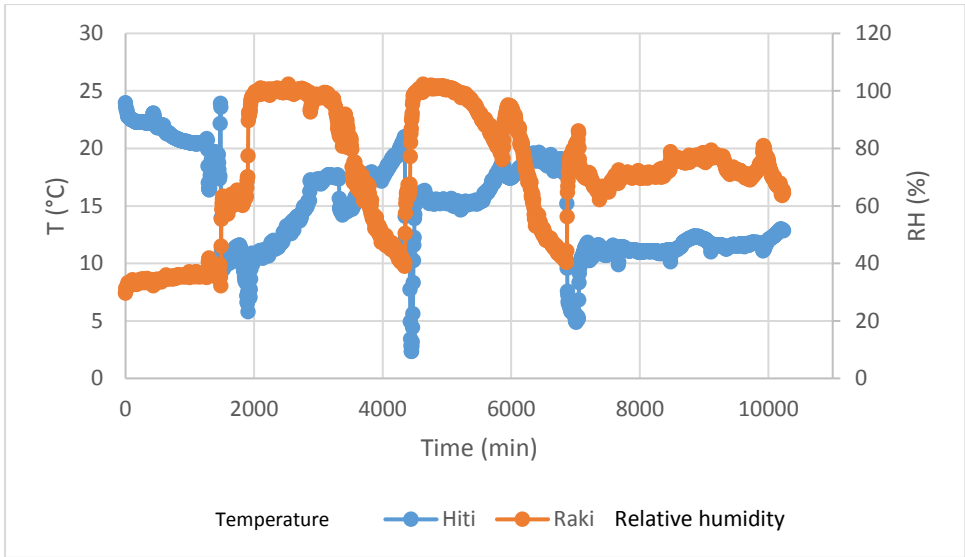
**Figure 21.** Temperature and relative humidity of exhaust air from the drying facilities.

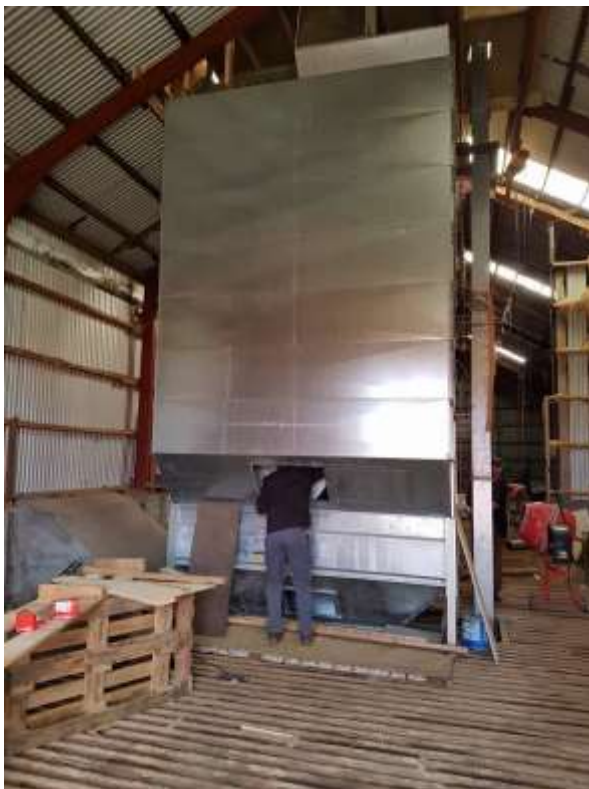
**Figure 22.** Installation of a dryer at Jaðar farm.

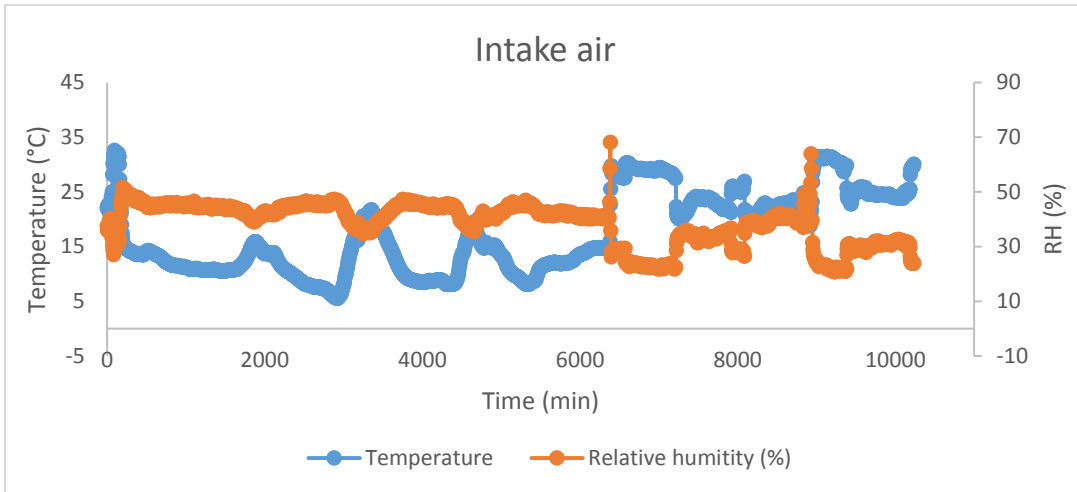
**Figure 23.** Temperature and RH of intake air.

Results are shown in Figures 23 to 30. It can be seen that the temperature of the intake air was below 35 °C and relative humidity below 70%. Outdoor temperature was constant at 14 °C during the drying operation. Measurement of exhaust air showed temperature below 35 °C and relative humidity up to 100% carrying the grain moisture. Highest air temperature inside the dryer was about 45 °C, indicating that grain was not overheated.

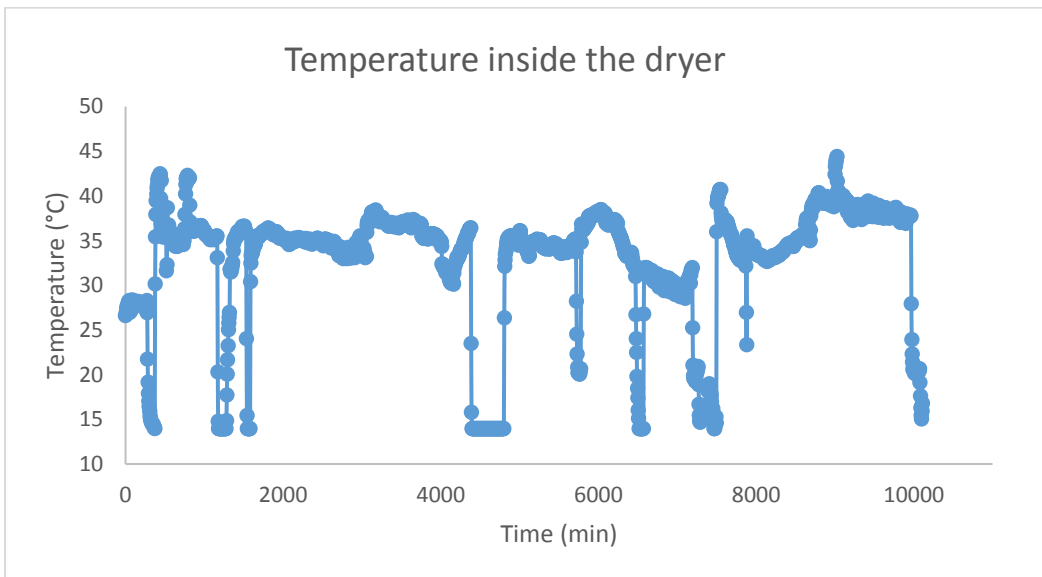
**Figure 26.** Results from temperature measurements inside the dryer (top).

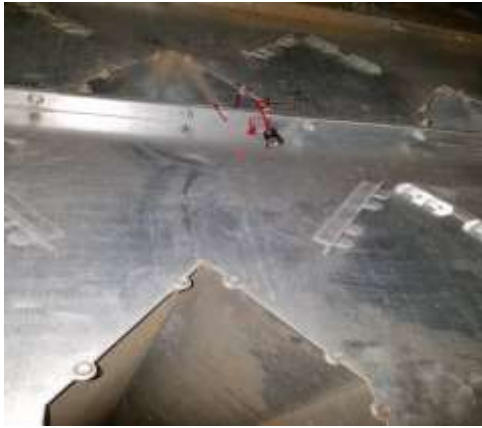
**Figure 27.** Location of a temperature sensor inside the dryer close to the top.

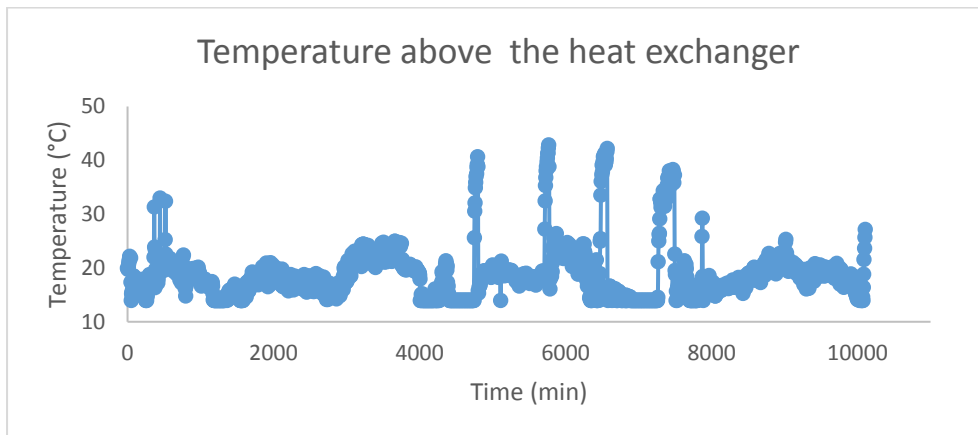
**Figure 28.** Measurements of air temperatures above the heat exchanger.

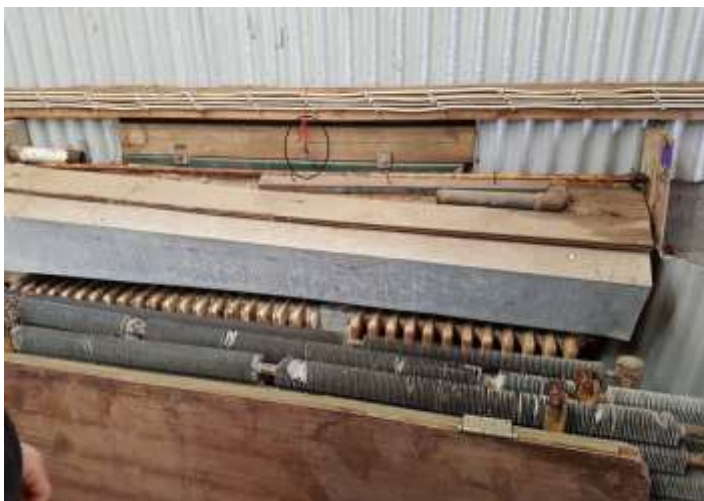
**Figure 29.** A heat exchanger for the dryer. A temperature sensor is located above the heat exchanger.

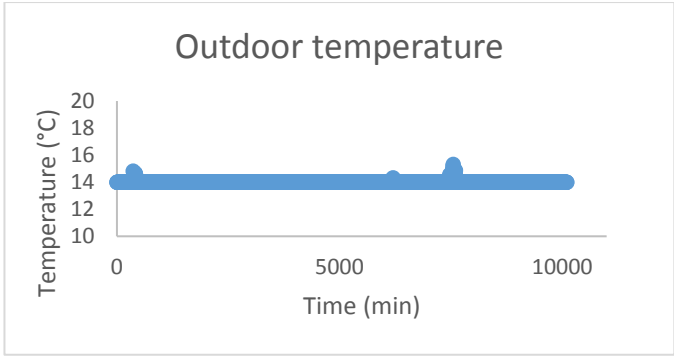
**Figure 30.** Temperature of air outside the building, quite stable at 14 °C.

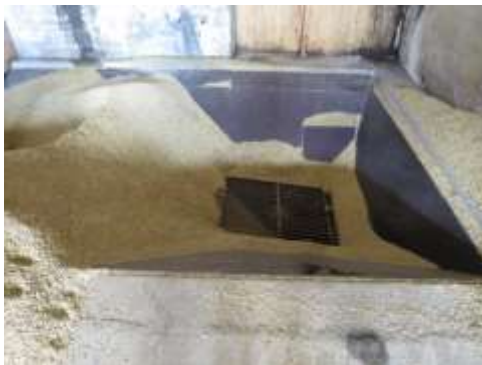
**Figure 31.** Intake of grain to the dryer.

The equipment was installed in an old fish meal factory and receives geothermal water at 80 °C from a local provider. Holes in the metal sheets of the dryer floor allow hot air to be blown through the grain for drying. Figure 31 shows the intake for grain to the dryer. Grain is transported mechanically to the top of the dryer where it circulates. After drying, grain is transferred to a storage tank (Figure 32). Finally, grain is transported mechanically to a transport truck outside the building.

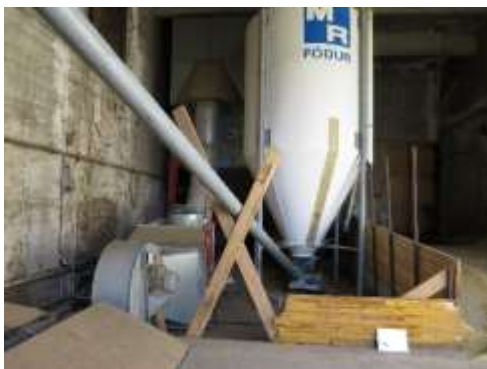
**Figure 32.** Storage tank for the grain.

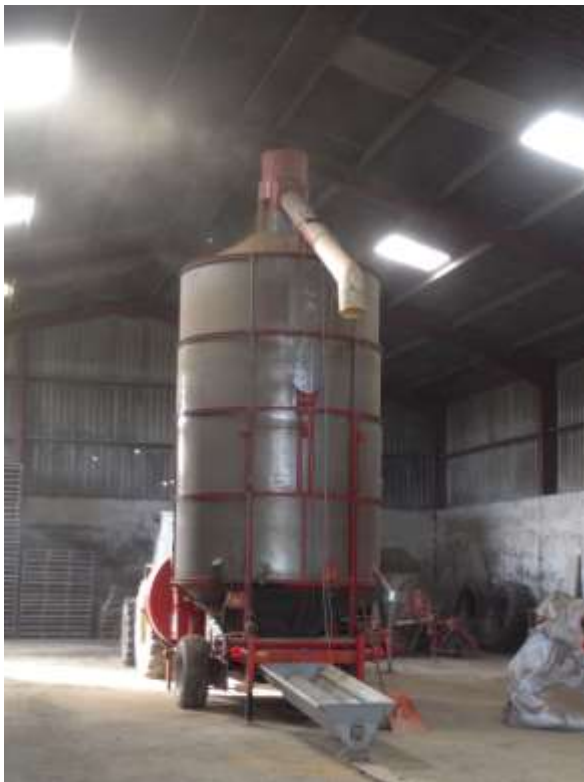
- Make- Master
- Type- Super 120 RS Batch drier
- Heating component- Pedrotti dual stage fuel burner, twin jet oscillating flame suitable for operation with dual fuel (diesel or kerosene)

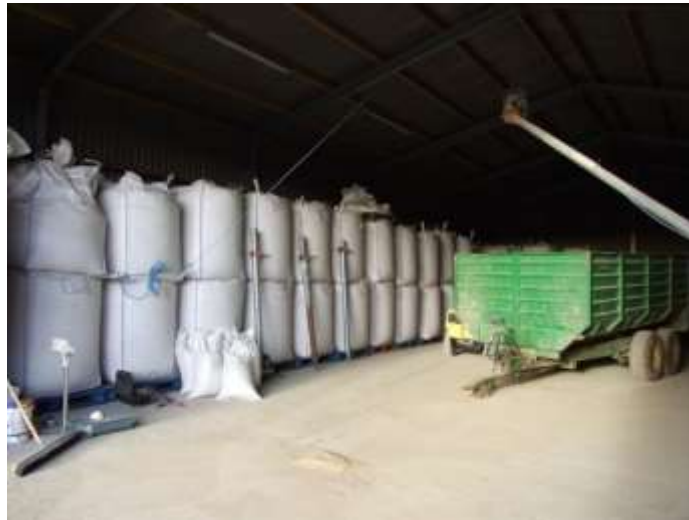
Description of facilities: Once dried, all grain is kept in 1 ton FIBC (flexible intermediate bulk container) bags and stacked in our grain store. The grain store is a 22.5 x 12 m portal framed building with mass concrete and half-clad fibre cement walls. The roof is clad with fibre cement sheets.

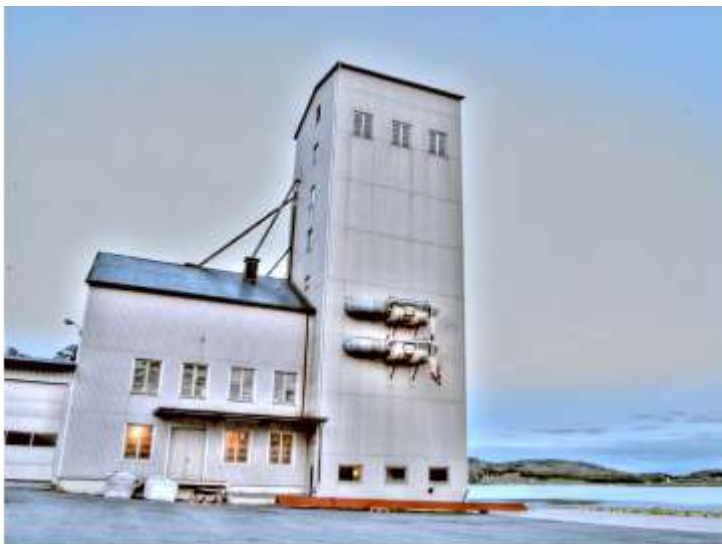
There is one drying plant within the region, the northernmost drying plant in the world. It is based at Berg, Sømna in Nordland. It is a cold air stream dryer, Monsoon TBGD/TBGE Norsk viftefabrikk. Before entering the dryer, the barley is cleaned and weighed (200 kg at a time) for deciding the payment to the farmer. Cold air drying requires that the grain brought in for drying is relatively dry in the beginning. After weighing the grain is put into the silo where 10 tons are dried at each time. There is only one cycle of drying. During drying, the grain is moved from the top and down in order to cool and dry it evenly. The drying temperature is similar to the outside temperature. The dryer is driven by electricity and is in use only during the harvest period in the autumn, mid-August to mid-September. After drying, the grains are moved to the factory for producing concentrated feed. The drying plant is owned and driven by Felleskjøpet Agri. Information was received from Jørn Henning Øyen.
